**National Highway
Traffic Safety
Administration**

Case Vehicle (A): 2000 Land Rover
 Type: Discovery II, 4-door SUV
 Driver: 32-year-old male
 CDC: 12-FYEW-3

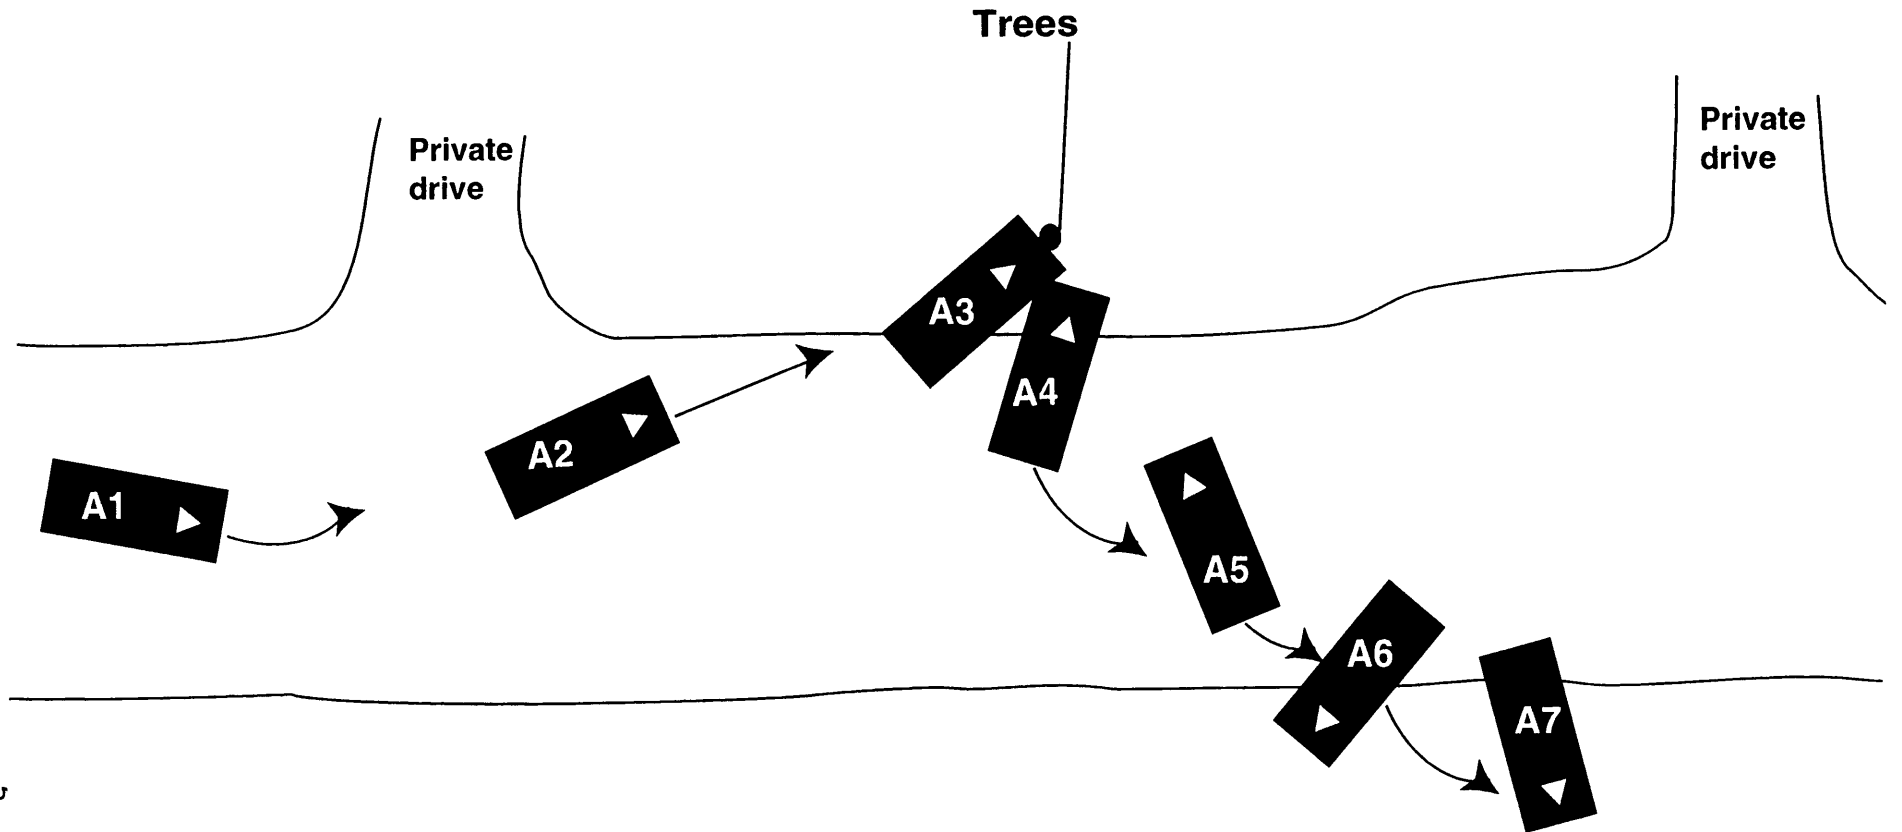
ACCIDENT SCHEMATIC

ACCIDENT DESCRIPTION: Case vehicle (A) was traveling in the eastbound lane of a straight section of a snowy, dirt roadway. The driver of case vehicle (A) had two day experience driving the vehicle. Case vehicle (A) began to fishtail to the left. The driver tried to correct the yaw, but lost control of case vehicle (A) as it began to fishtail to the right. Case vehicle (A) drove off the left side of the road and struck a tree, entered a clockwise rotation, crossed the road, and came to rest on the right shoulder facing south.

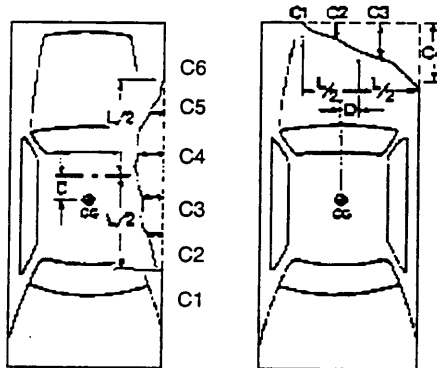
Specific Impact No.	Location of Direct Damage	Location of Field L
1	Begins +50 cm from Front bumper corner	B.C. to B.C.

DL 45
UDL 130

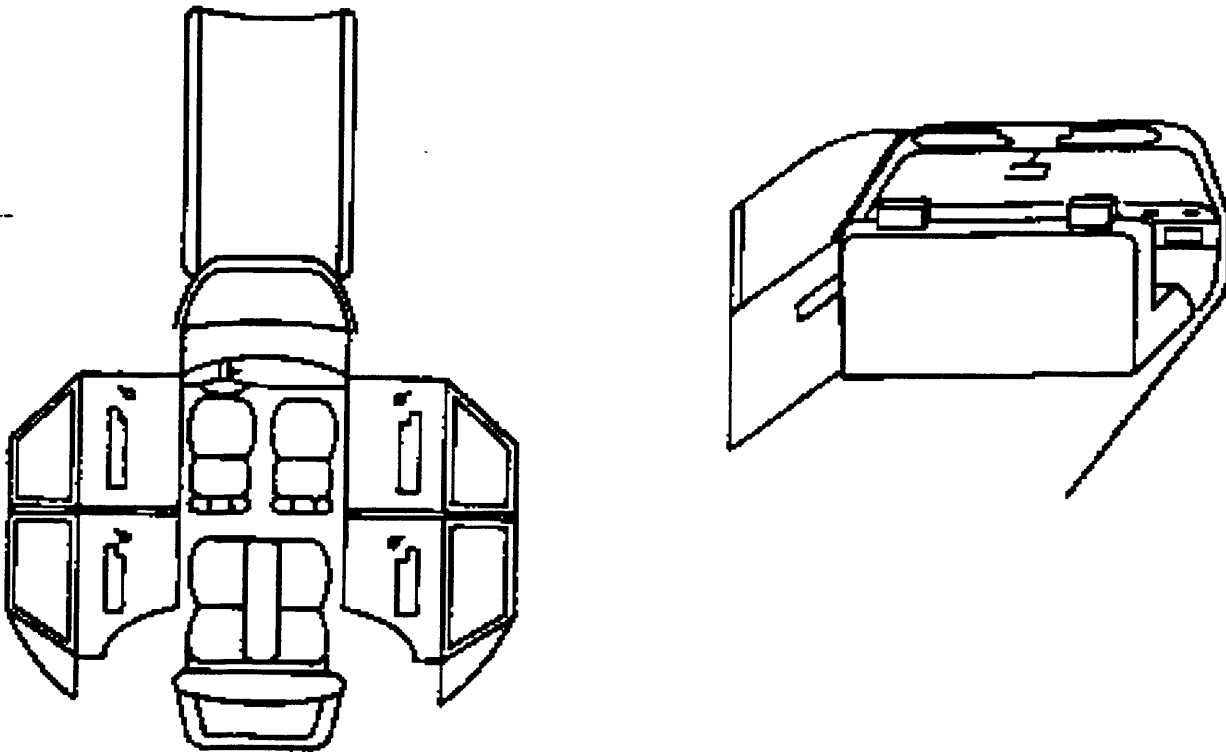
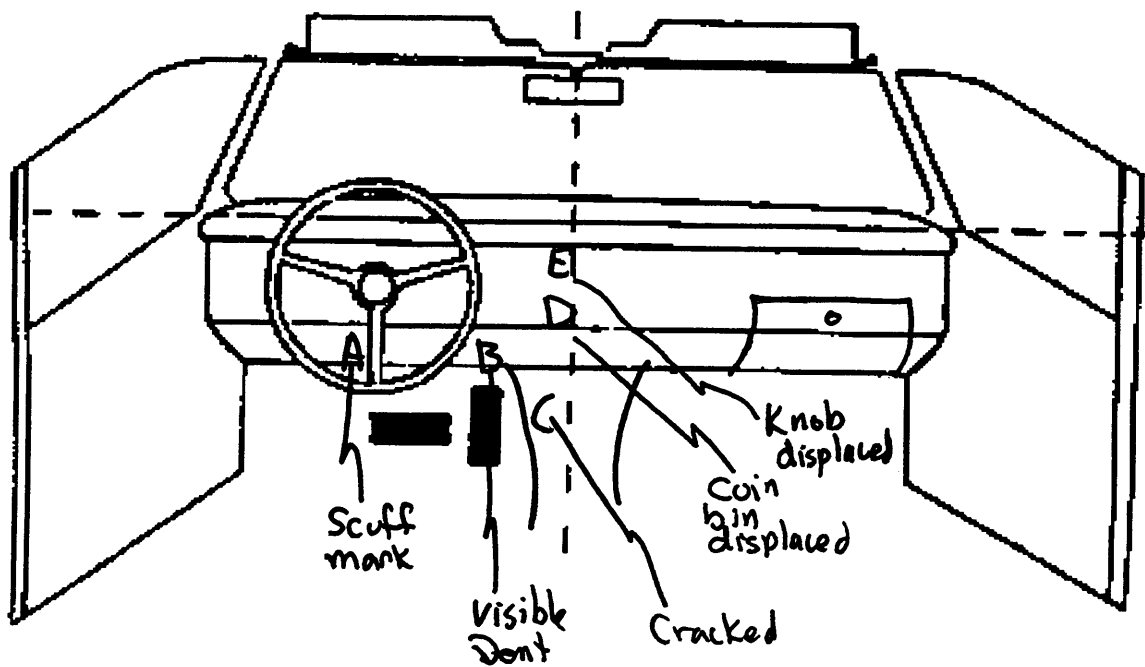
VEHICLE OCCUPANT CONTACT DIAGRAM

Contact	Interior Component Contacted	Occupant No. if Known	Body Region if Known	Supporting Physical Evidence	Confidence Level of Contact Point
A	knee bolster	1	Knee	scuff mark	1
B	knee bolster	1	knee	visible dent	1
C	vert. console	1	thigh	cracked	1
D	cfr. I.P.	1	Chest	coin bin displaced	2
E	Ac.van t	1	Chest	Knob displaced	2
F					
G					
H					
I					
J

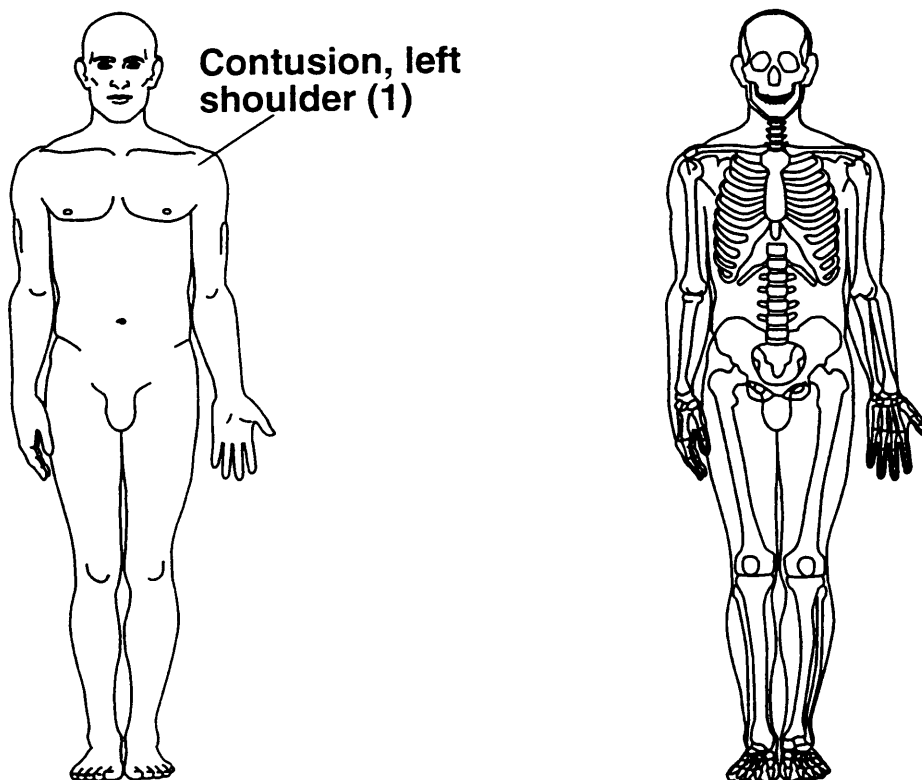
Injury Description	A.I.S.	Injury Source		
		Definite	Probable	Possible
Contusion, left shoulder	1	Shoulder belt webbing		
<u>Maximum A.I.S. Level</u>	1			
<u>Injury Severity Score</u>	1

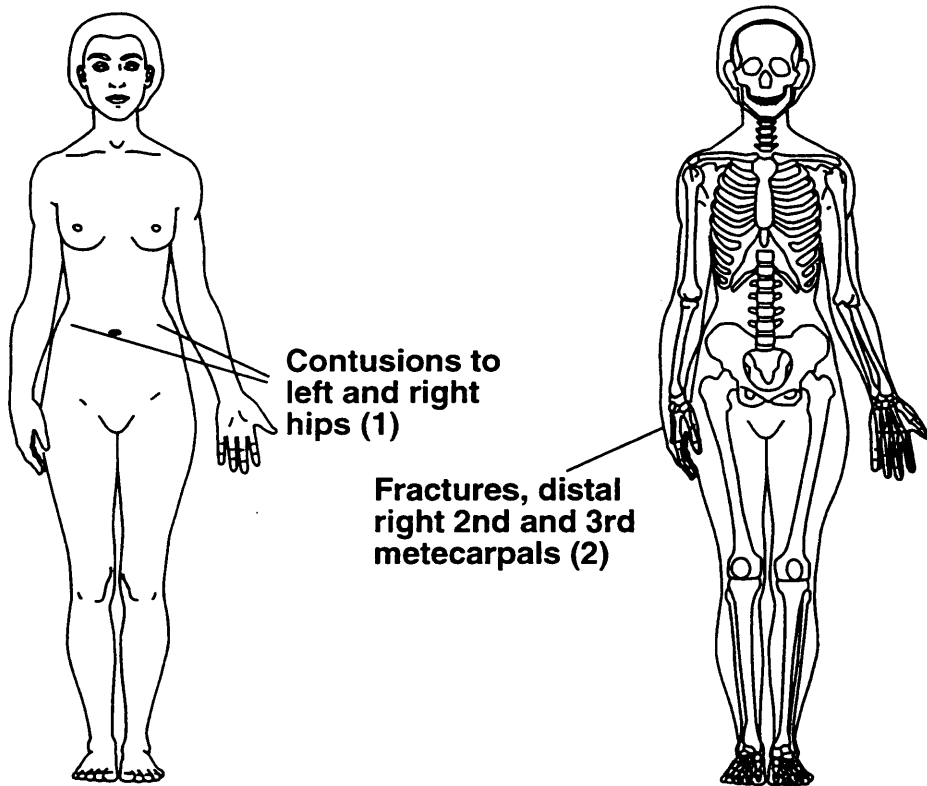
Injury Description	A.I.S.	Injury Source		
		Definite	Probable	Possible
Fractures, impacted distal right 2 nd and 3 rd metacarpals	2			Interior side surface – airbag fling
Contusion, left hip	1	Lap belt webbing		
Contusion, right hip	1	Lap belt webbing		
<u>Maximum A.I.S. Level</u>	<u>2</u>			
<u>Injury Severity Score</u>	<u>5</u>
